This document is for use with Sierra's BioTrak 645S, BioTrak 645, TM100, and TM500 insertion models.

The purpose of this procedure is to ensure that the customer welds the branch fitting to the pipe correctly. This process directly affects the flow meter installation, ensures that the meter performs properly, and also ensures that damage to the probe does not occur.

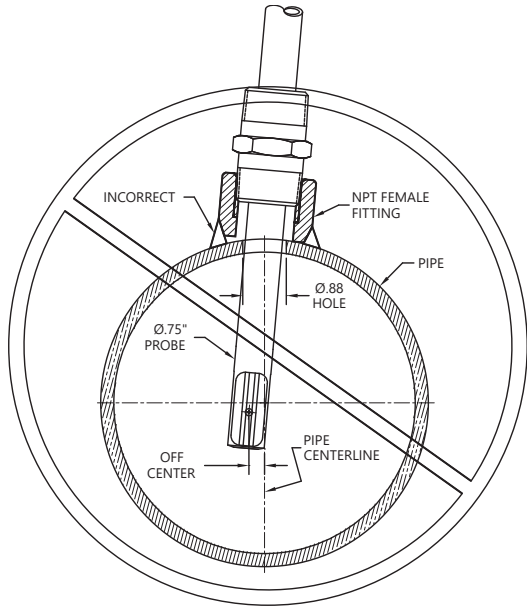
Figure 1: Incorrect Alignment of Branch Fitting

1. Drill a 0.781-inch (25/32") hole through the wall of the pipe (1 wall only).
 - Hole must be centered with respect to the fitting.
2. Assemble the hex nipple and branch fitting hand tight onto the probe of the flow meter.
3. Insert the probe into the hole in the pipe and use the flow meter probe and compression fitting to align the branch fitting with the hole and the probe perpendicular to the pipe.
4. Tack-weld the branch fitting carefully onto pipe with proper alignment.
 - It must be perpendicular to pipe in both planes (see Figure 1 on next page).

- The branch fitting must position the probe window on the pipe's centerline.
 - Figure 1 shows an incorrect welding of the branch fitting, causing the 0.75-inch sensor to be "off center".

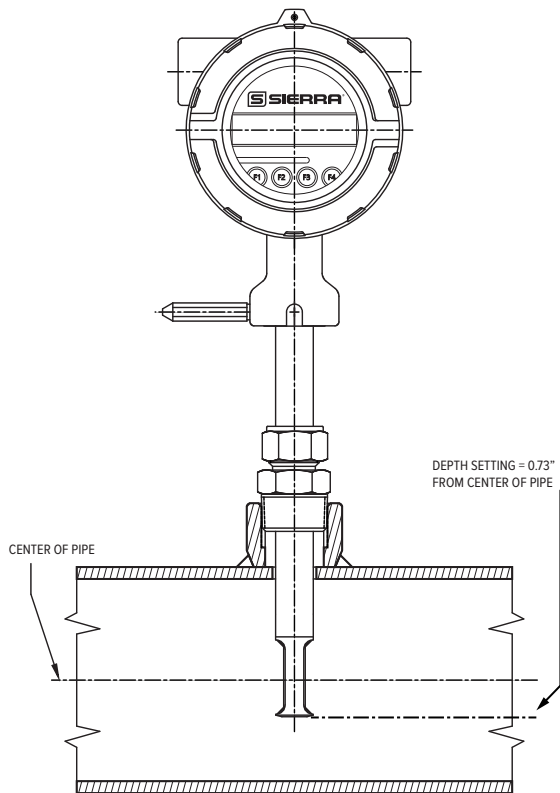
Figure 2b: Correct Alignment of Branch Fitting and Sensor Elements Centered in Pipe (without retractor)

5. Verify that the correct hole position has been achieved (see Figure 2 on next page).
 - If retractor ordered: Assemble the retractor and flow meter together by "hand tightening" to the branch fitting.
 - Slide the 0.75-inch sensor through the 0.781-inch hole.

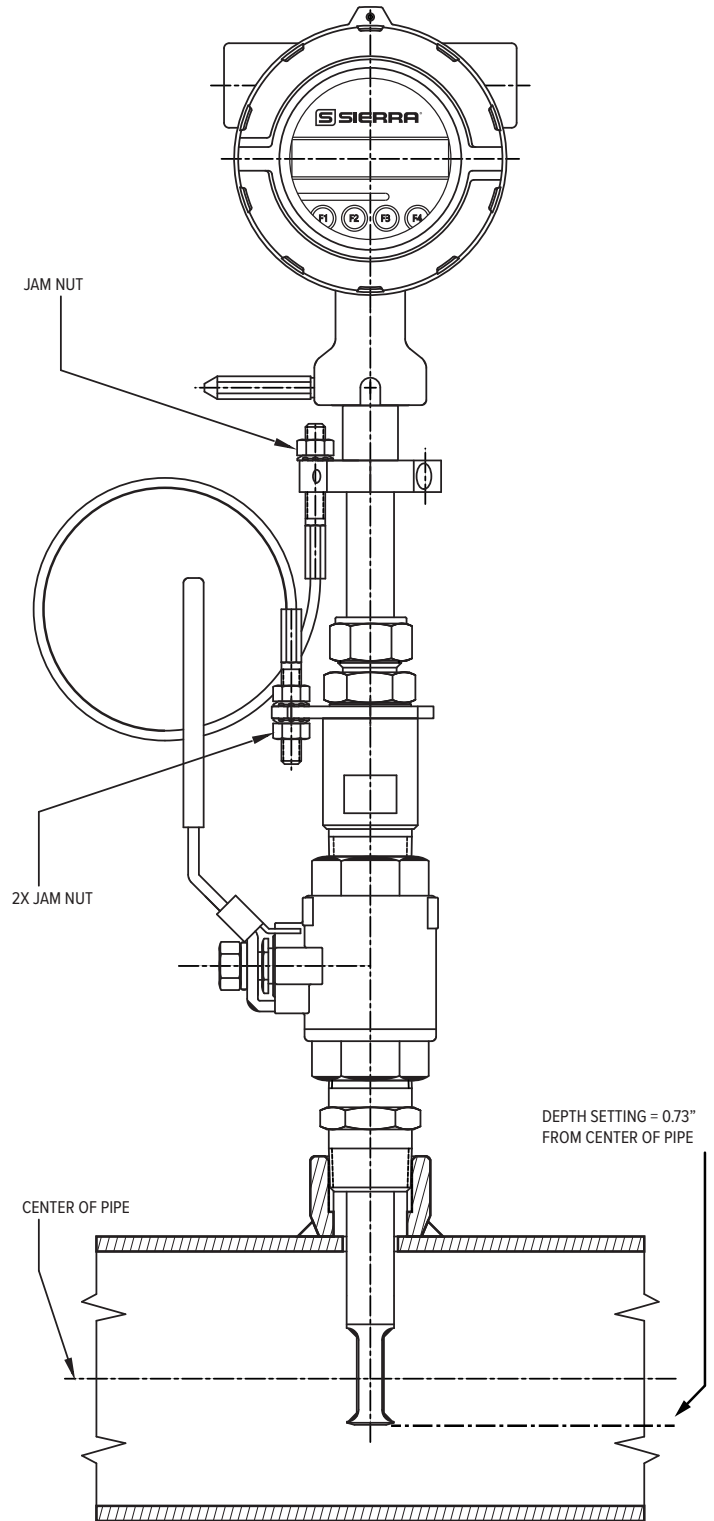
Figure 2a: Correct Alignment of Branch Fitting and Sensor Elements Centered in Pipe (with retractor)
